MILL CREEK PASSAGE GOSE STREET CONCEPTUAL DESIGN

PROJECT # 21-1010

DRAFT - BASIS OF DESIGN REPORT

Geomorphic Assessment of the Gose Street Reach of Mill Creek near Walla Walla, Washington

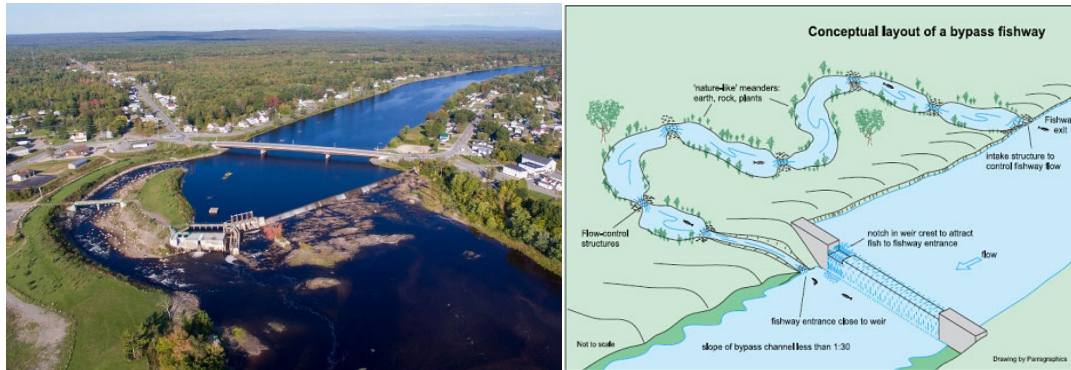
Figure 5-1. Velocity Barrier

Figure 10 – Velocity barrier example. Sketch to the right is a profile view.

Option 4 is a 1560-foot-long bypass channel with a slope varying from 0.5 to 4 percent. The flow in the channel would vary from 10 to 100 cfs. The channel width would average 20 feet. Construction of a velocity barrier dam 1300 feet downstream of S. Gose Street would be required to force fish into the channel (Figure 10). Initially this dam is proposed as a velocity barrier dam to reduce the amount of backwatering and depth upstream. At the upstream end of the channel, it would cross under S. Gose Street in a 10-to-12-foot diameter culvert and then into a flow control section with either a slotted fishway or an automated closure gate to reduce the potential for flood flows entering the channel. The bypass channel would be a natural channel (not fishway) constructed of appropriately sized streambed cobbles and boulders with a riparian corridor. The channel would be set back 20 feet from the top of the bank. At the

downstream end the channel would be constructed 3 to 4 feet below the existing bed to account for future channel incision.

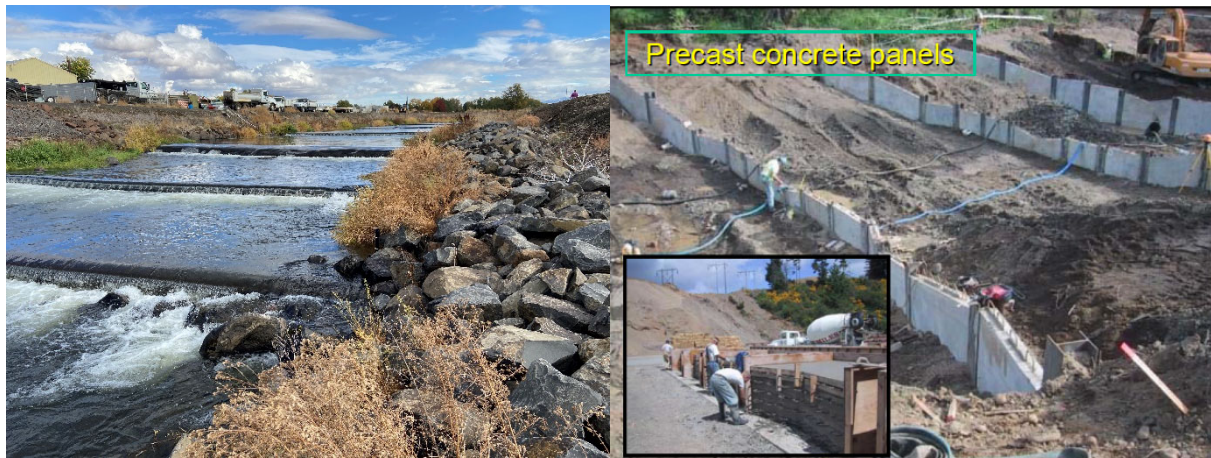
Figure 11 – Concrete weirs spanning channel constructed in 2005 (left) and Goldsborough Creek Concrete Weirs (right) during construction.

Option 5 would be a series of 20 concrete weirs spanning the channel with 1-foot drops. The weir spacing would be 40 feet and the overall channel slope 2.5 percent. The weirs would have a low flow notch and look very similar to the weirs upstream of S. Gose Street in the flood control channel. The weir length would be 40 to 50 feet. The weirs would be shaped to concentrate flow more in the center of the channel. This Option requires the existing fishway under the bridge to be modified as described in Option 1. Two design options are shown in Figure 11.

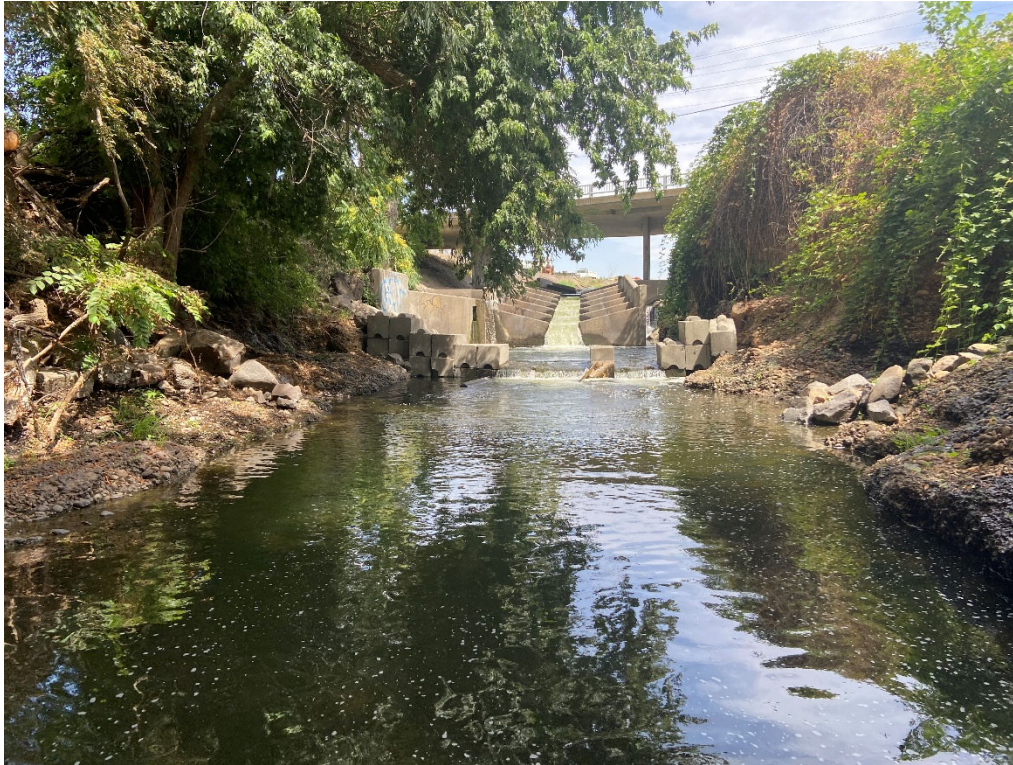
Photo 1 – View upstream of the lower fishway at 14 cfs (8/2/2022).

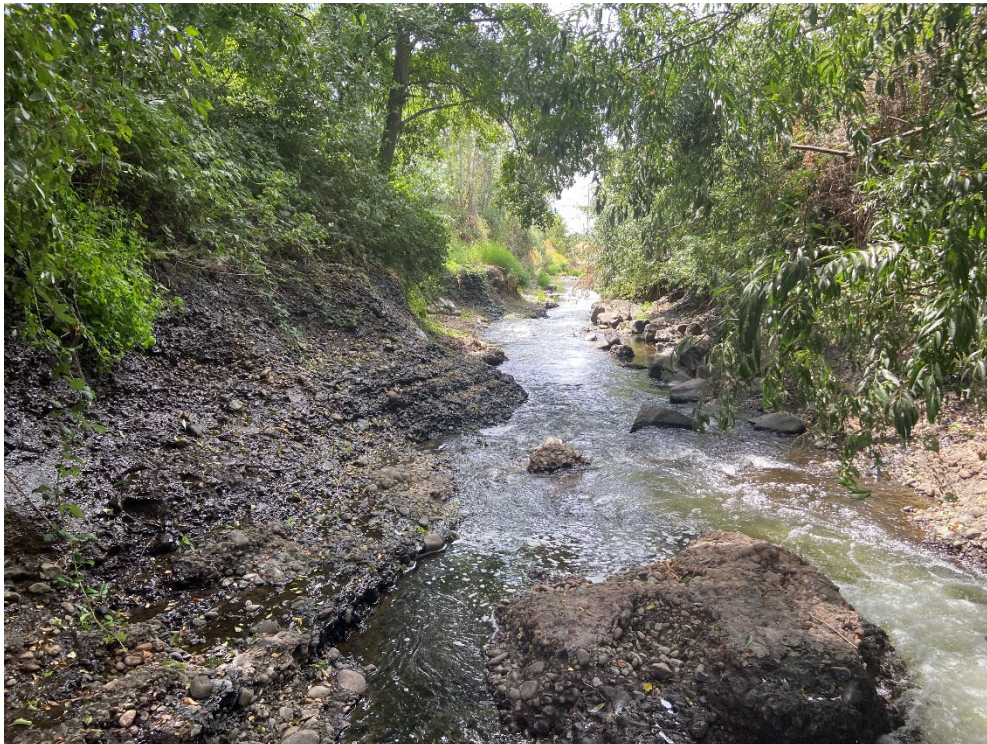
Photo 2 – View downstream of fishway at 14 cfs (8/2/2022).

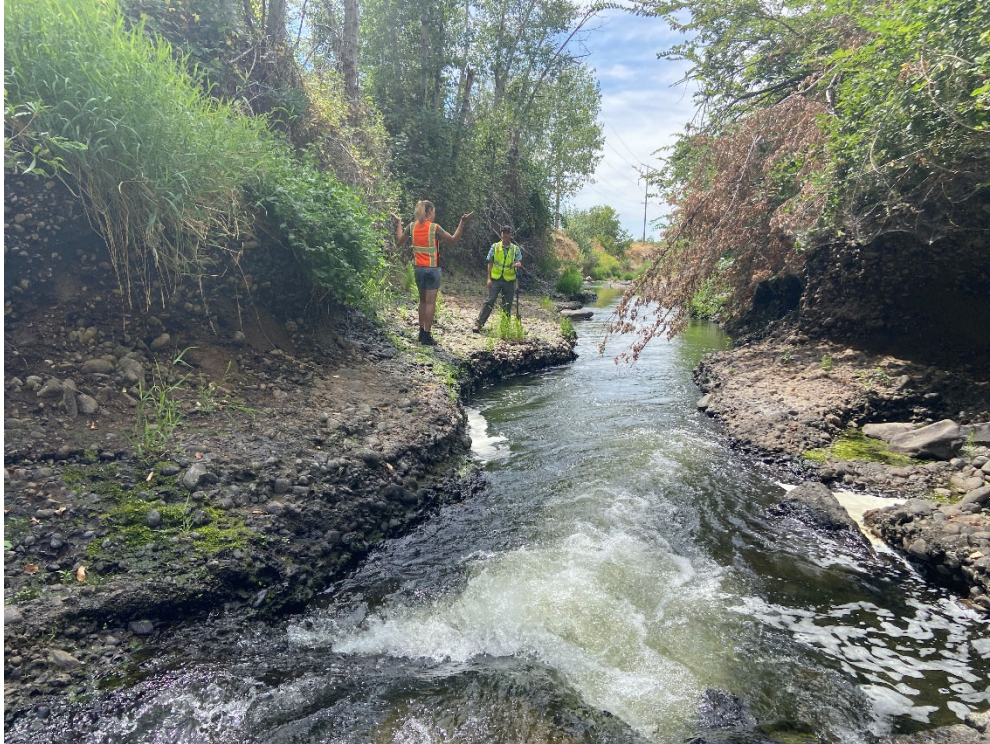
Photo 3 – Mill Creek channel downstream of Gose Street (STA 21+00).

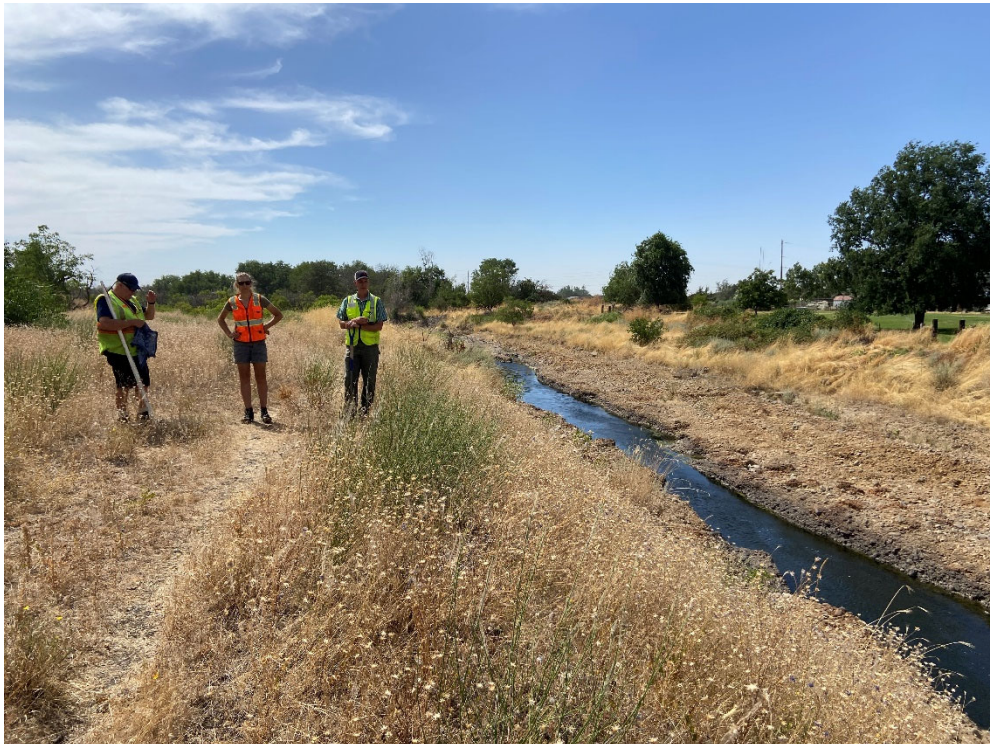
Photo 4 – Mill Creek STA 14+00 view downstream. Stationing starts (0+00) at Hussey Road.

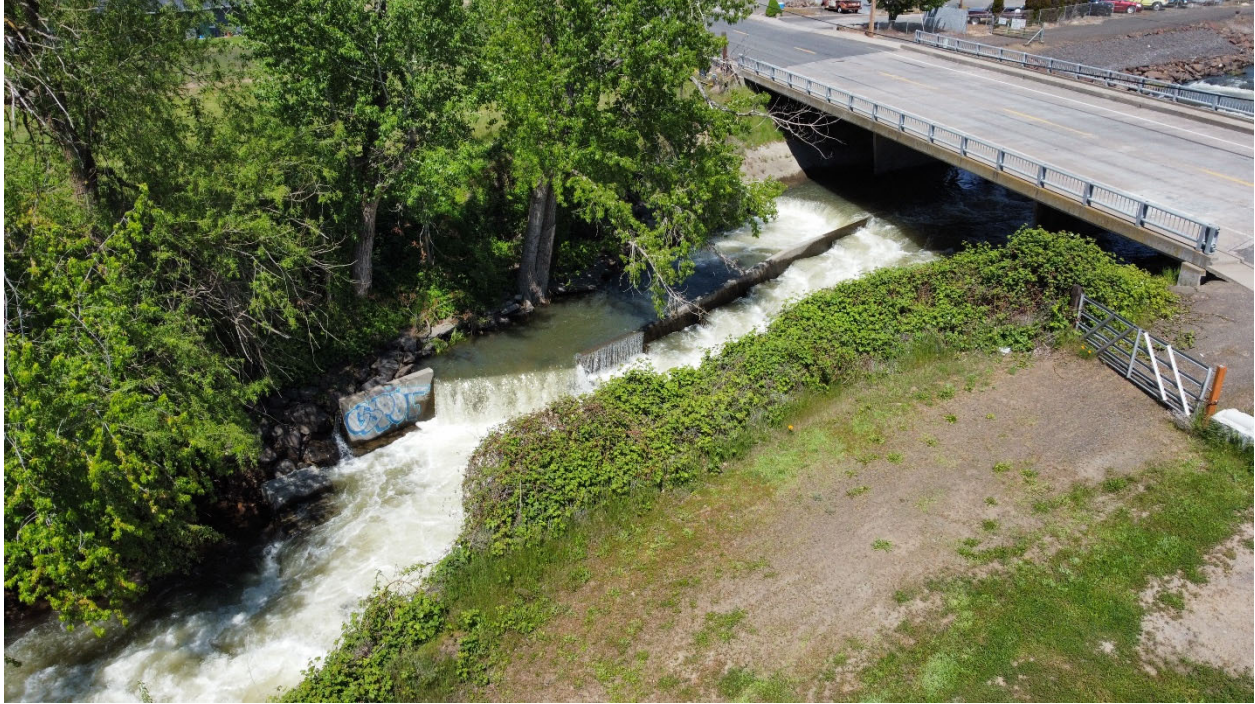
Photo 5 – Drone photo from May 11, 2022 (flow 400 cfs).

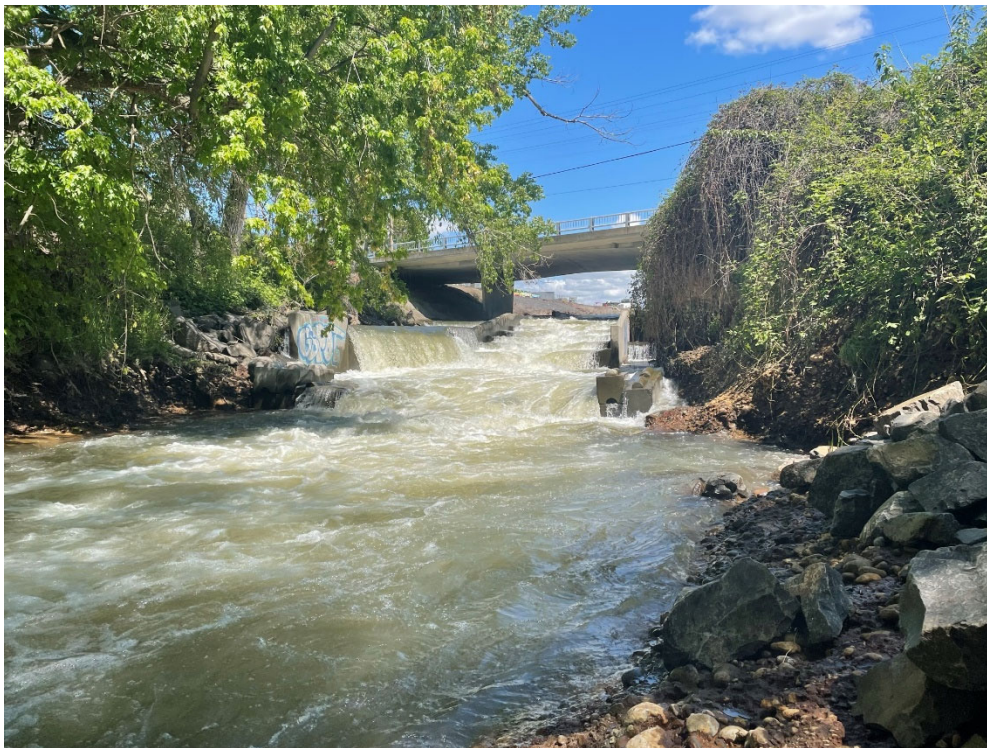
Photo 6 – View upstream of fishway at 400 cfs. Note: the Upper design flow for the Mill Creek Fish Passage Project is 320 cfs (Adult Steelhead).

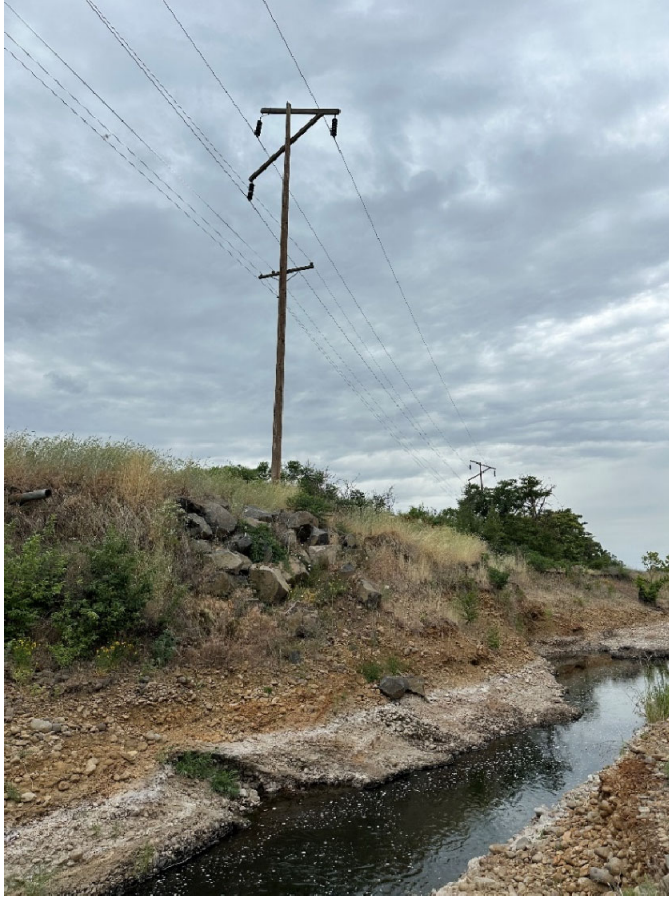
Photo 7 – Pacific Power transmission line on left bank of Mill Creek.

After Option 2 was selected as the preferred design, additional detail was added in an effort to address landowner concerns and other site details. Pacific Power has three large transmission lines on the left bank of the property (see Photo 7). Bank erosion has threatened one pole and riprap has been dumped/placed to prevent further erosion. Options to move the channel widening more to the right bank are being explored with landowners which may eliminate the need to move the poles. The cost of relocating the lines is also being pursued with Pacific Power.

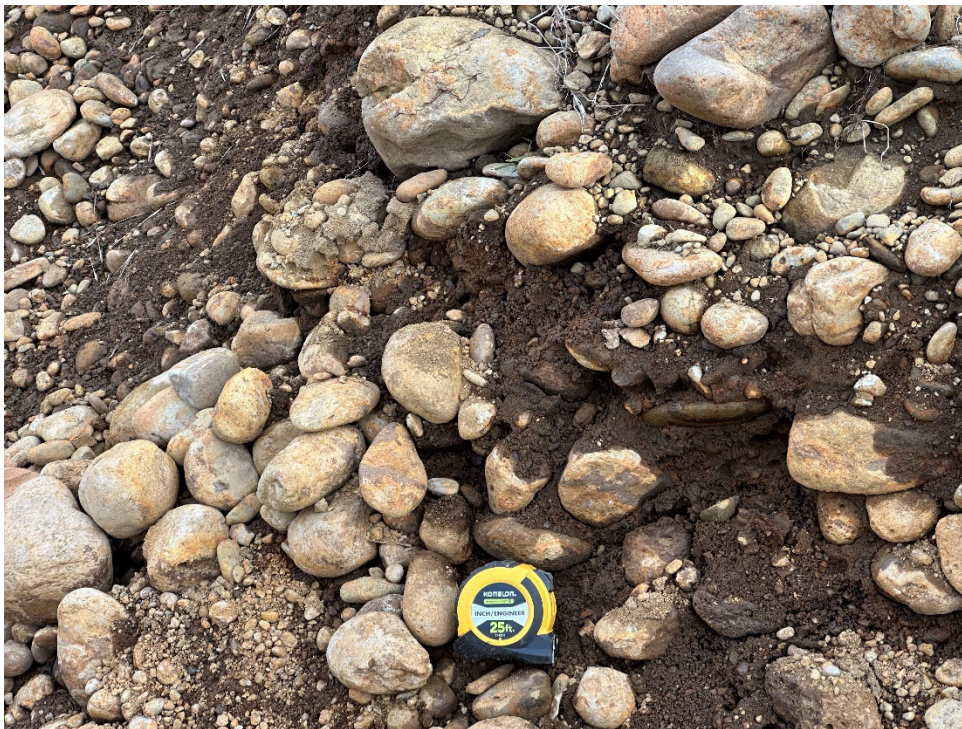
Photo 8 - Typical bank material along Mill Creek downstream of Gose Street.

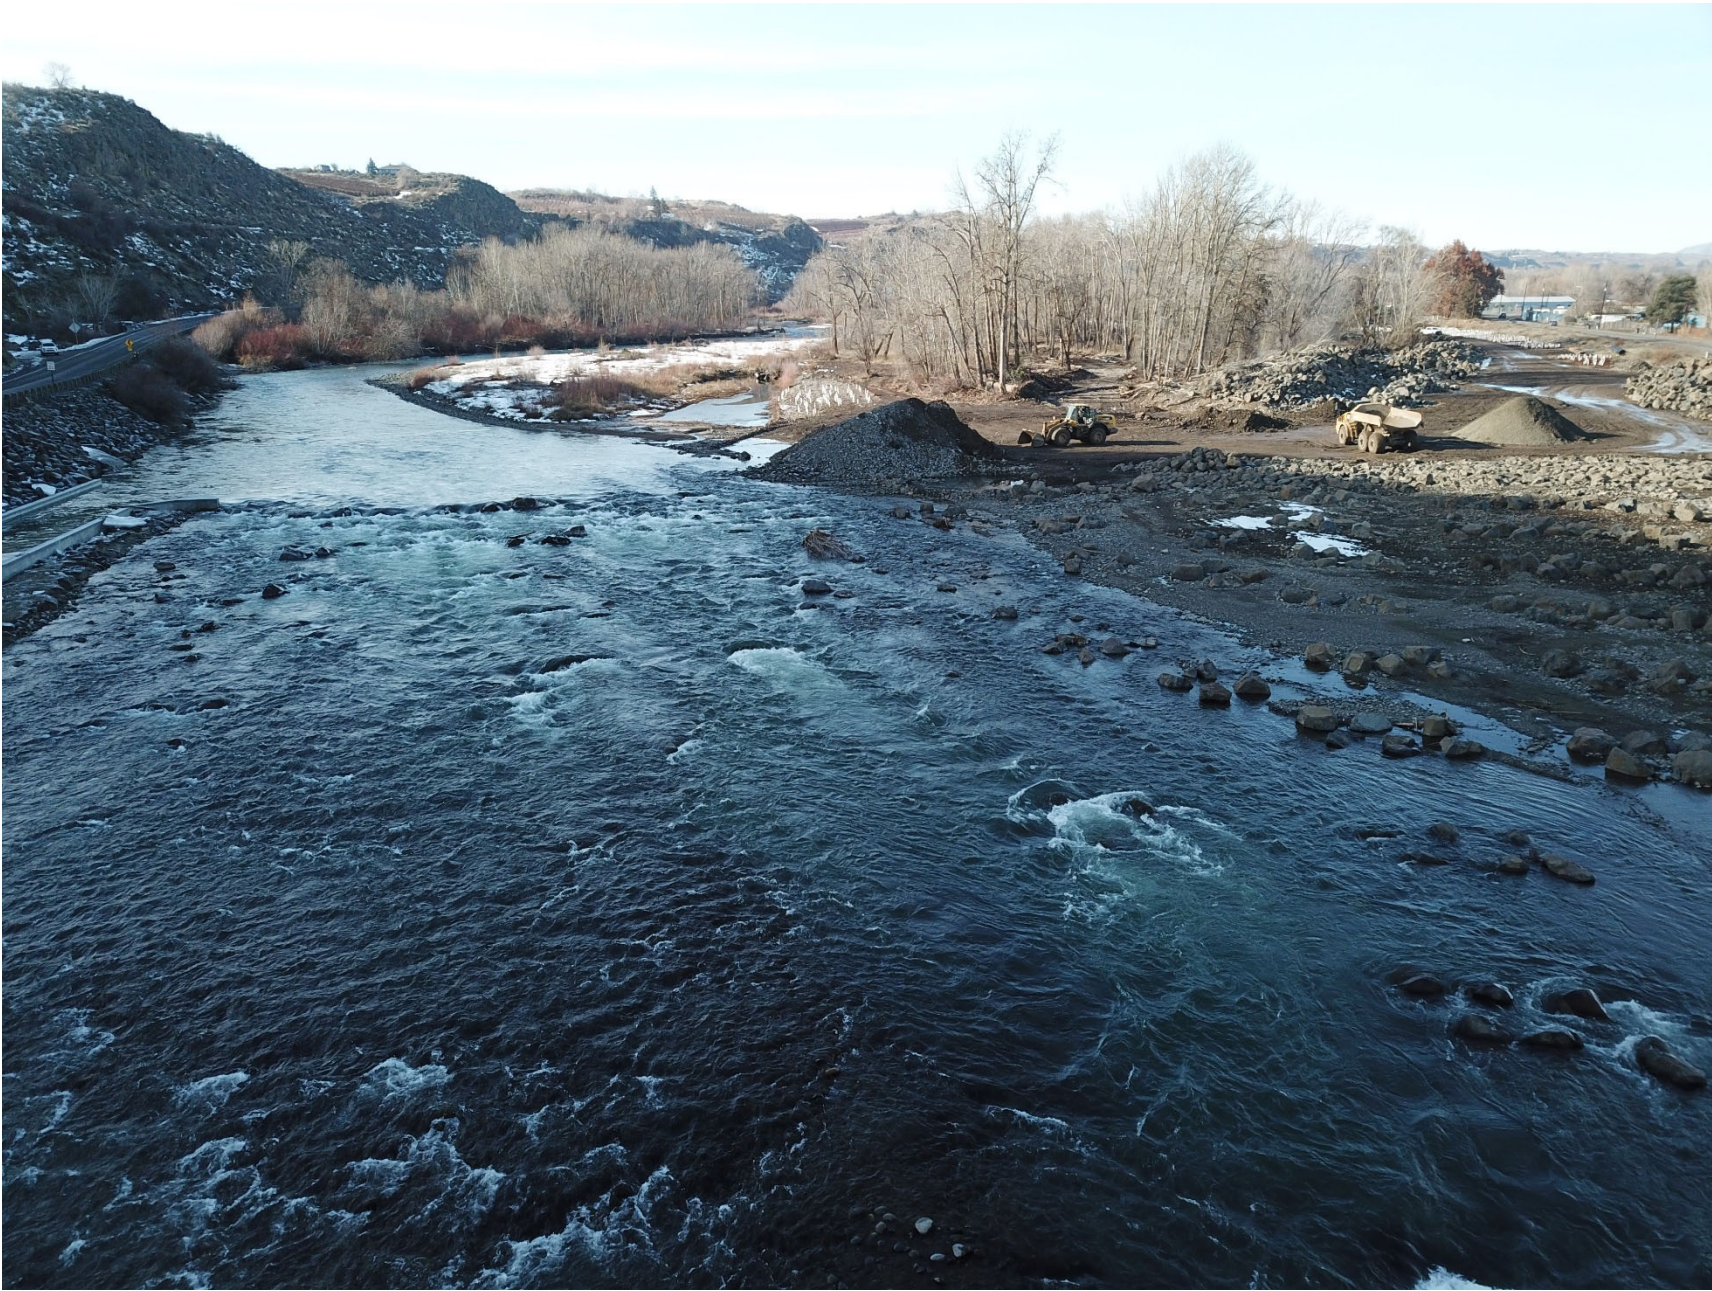
Nelson Dam Nature-Like Fishway, Naches River. Constructed 2021/22. Slope ~ 2%
